Bourgault Air Seeder--Chickpea Seeding

Introduction

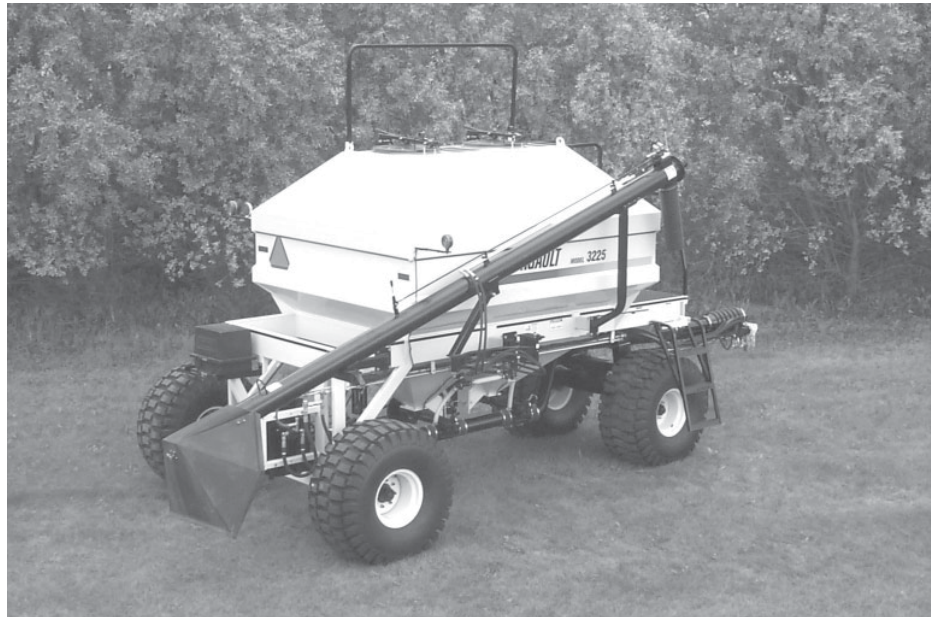
A Bourgault 3225 air cart with a PDM metering system and air kit with 5 Quick Inspection manifolds and 50 outlets was used for the test. The air kit was designed for a 40.8 ft (12.4 m) air drill with 9.8 in (25 cm) row spacing.

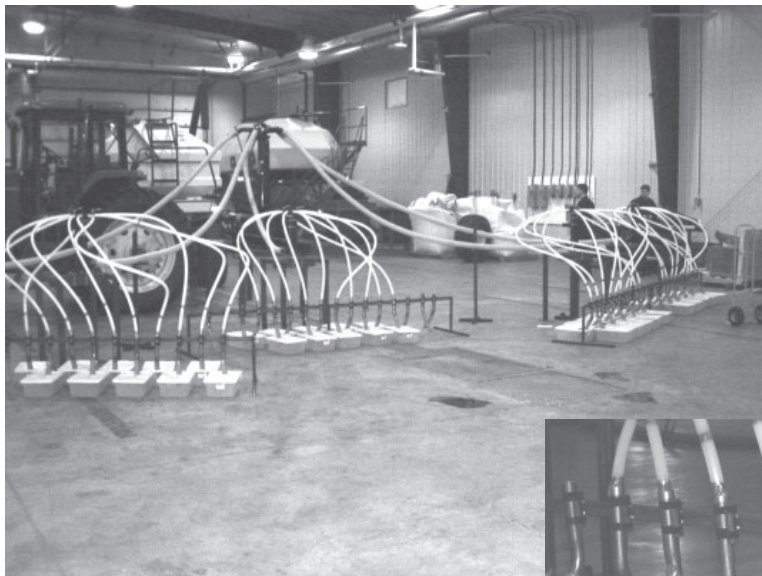
Test set-up.

The seed damage tests were conducted with the air tank/air delivery system on a level surface. The manufacturer’s seed boots were replaced with a “standard” boot to ensure machine performance was not affected by boot design. A rubber hose was attached to the discharge end of the boot to direct seed into plastic catch tubs.

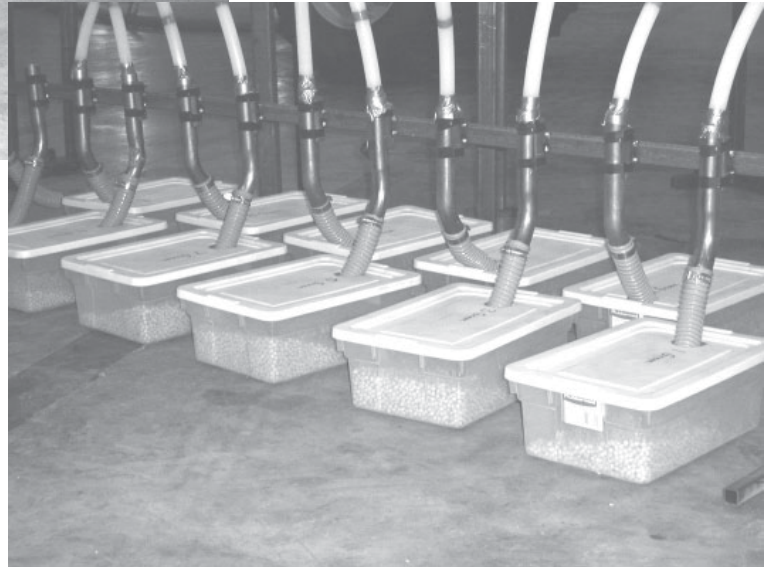
Collection tubs.

method at a simulated ground speed of 4 mph (6.4 km/h). Air tank/air distribution samples were collected in plastic tubs at the end of each delivery hose. Samples were combined from each outlet and divided down for damage assessment.

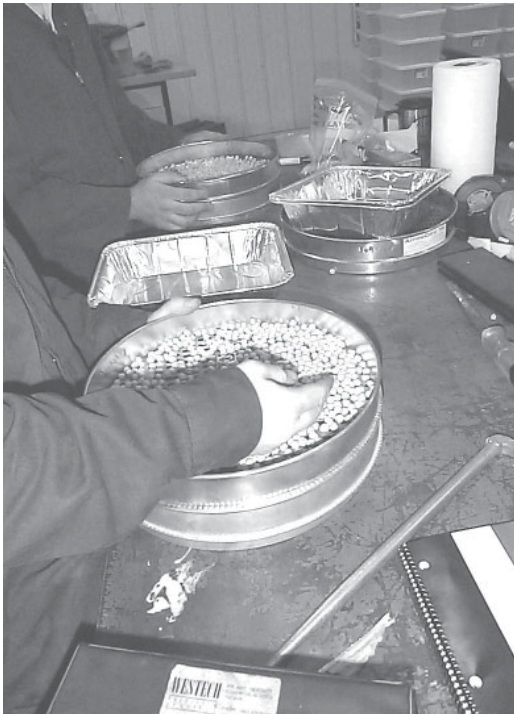
Sorting seeds for damage.

Chickpea damage was evaluated by two different methods. The first method was by visual inspection of physical seed damage including splits, cracks, or any seed coat penetration. Physical seed damage was quantified by removing damaged seeds from the sample and expressing this weight as a percent of the original sample weight. The second assessment method was to quantify hidden damage to the seed. Hidden damage was determined by sending the good, undamaged seeds to an accredited seed lab for germination tests. Total damage was calculated as the sum of percent physical damage plus the percent reduction in germination. Net damage due to seed metering and distribution was calculated by comparing the difference between the physical and germination damage of the treated samples with check samples.
